Zion Landfill

Surface Emissions Monitoring

1st Quarter 2016 Report

RE: Advanced Disposal Zion Landfill – 1st Quarter 2016 NSPS Surface Scan

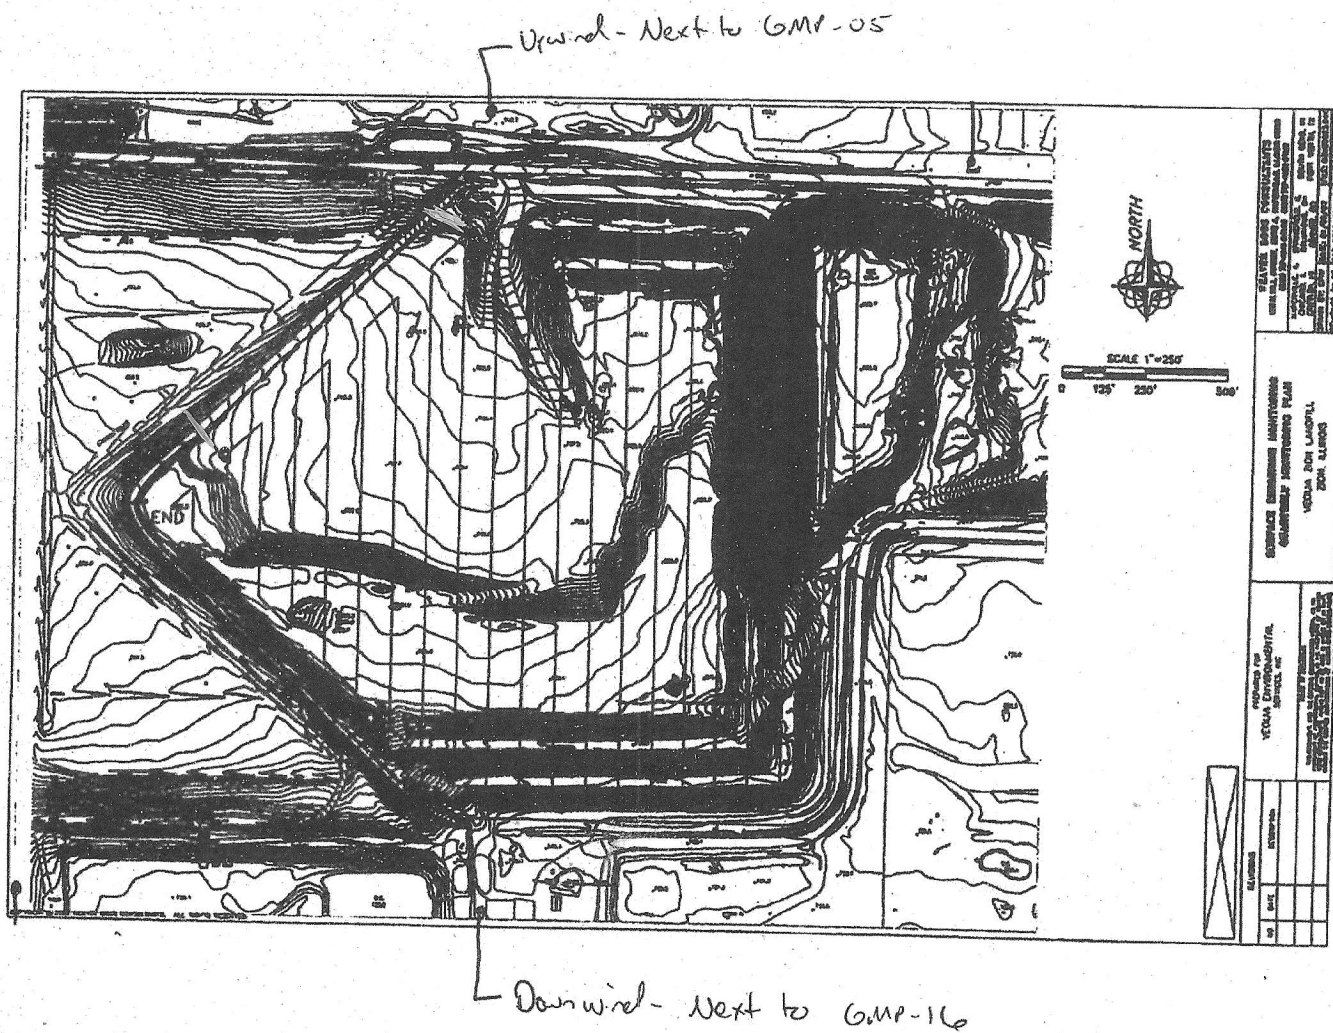
Surface Emissions Monitoring
Topographic map with monitoring route

Zion - Advanced Disposal SEM
 3-18-2016
 0 Exceedances
